SAN PEDRO CREEK WATERSHED SEDIMENT SOURCE ANALYSIS

Prepared for

City of Pacifica, and

**Volume I:
Background and Synthesis**

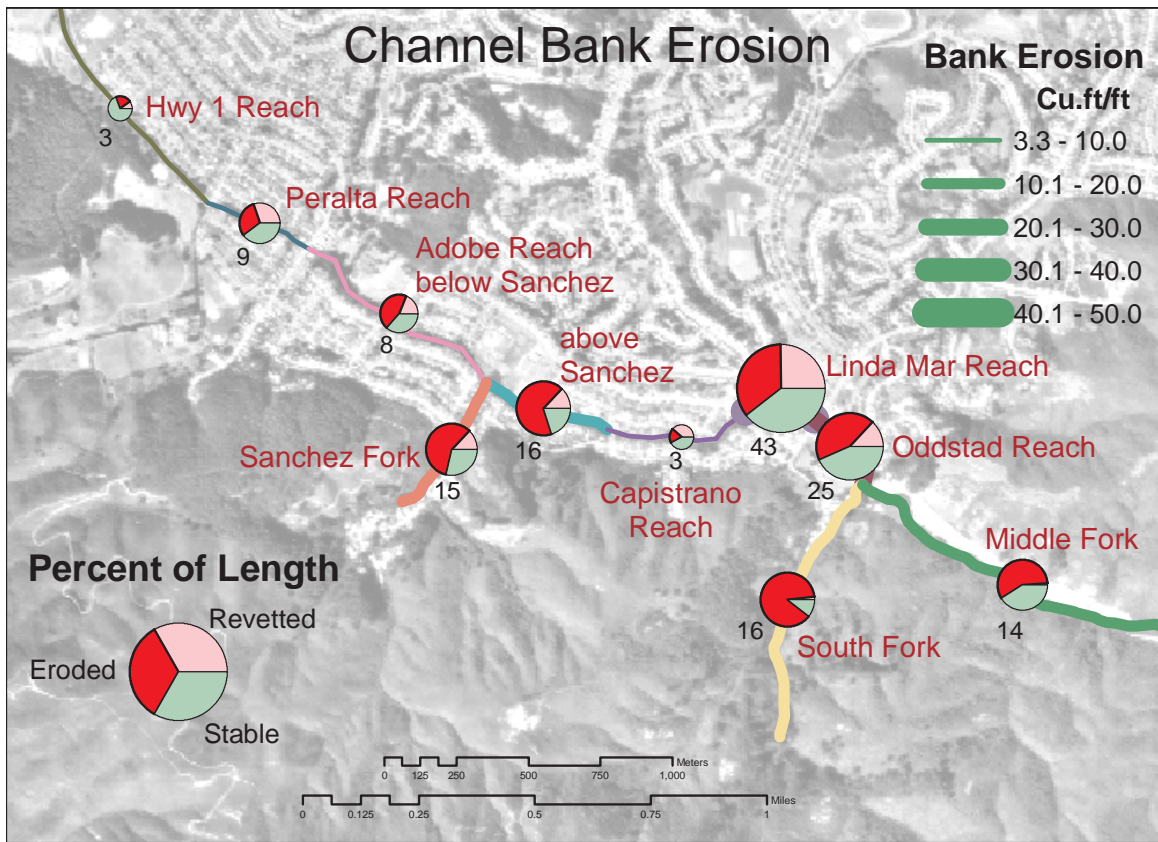
Figure 2. Bank Erosion: Normalized volume (ft³/ft) and percent of length revetted, eroding, and stable. Circles also proportional to normalized bank erosion volume.

Clearly, much of San Pedro Creek has experienced significant erosion, with the greatest concentration attributable to the effect of impervious urban runoff, especially the Linda Mar Reach at the confluence of the largely culverted North Fork. This reach includes sections downstream and upstream of the confluence, and has experienced 42.9 ft³/ft of bank erosion. No significant difference was noted between upstream and downstream sections; incision at the confluence is clearly influencing both sections. The Capistrano reach immediately downstream experiences much less erosion, stabilized as it is by a grade control structure at Capistrano Bridge, but below this structure erosion dramatically increases, where 2/3 of the channel length is eroding, with 15 feet (4.6 m) of incision in the last 50 years. This has created the greatest barrier to steelhead migration in the system.

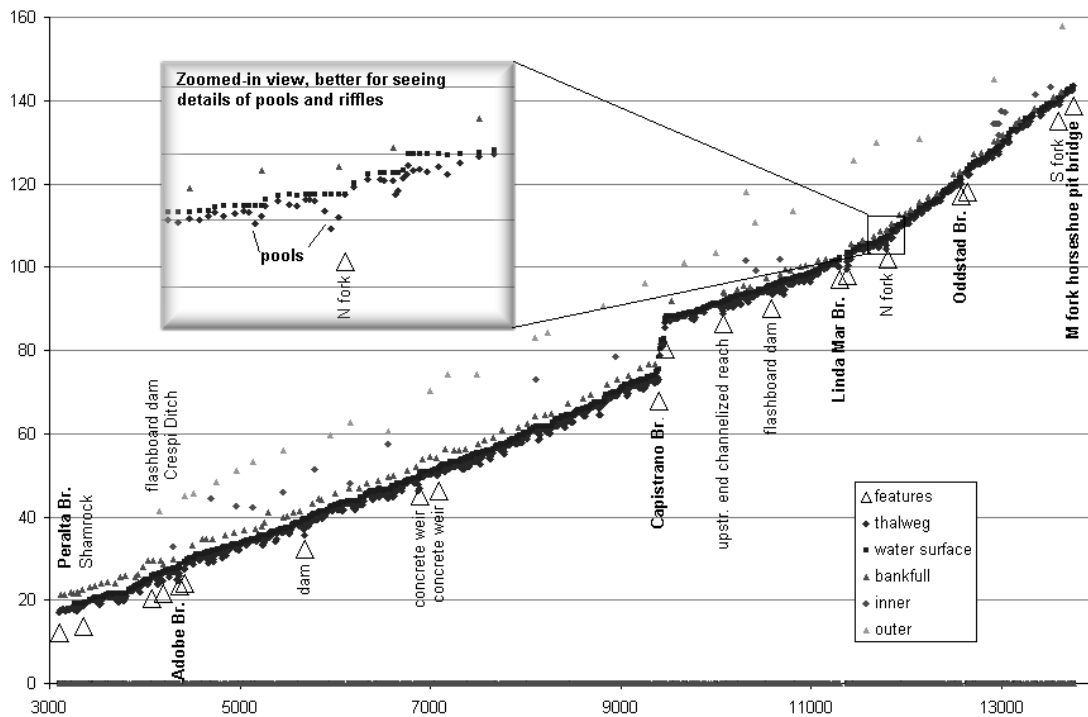
Figure 3. Main stem longitudinal profile. 2002 survey by Jerry Davis and Laurel Collins.

1. The grade control structure at Capistrano Bridge. Below the structure fifteen feet of vertical erosion downstream of the structure has created a serious barrier to fish migration, and severe bank erosion downstream. A succession of largely ineffective fish ladders have been installed, but this barrier remains and addressing it is a top priority for improving passage to important habitat upstream.

2. Both downstream and upstream of Capistrano, the creek's gradient has eroded to a lower gradient than must have existed before settlement. The average baseflow gradient below the Capistrano fish ladders and above Adobe Bridge is 0.91%, with a similar gradient (0.90%) at the bankfull level. In this reach, the uppermost terrace, which appears to relate to the bankfull level before settlement, has a gradient of 1.07%. The lowered channel gradient is likely the result of erosion from more frequent peak flows from urban runoff (rainfall on paved areas runs off quickly.) The potential for further erosion will depend upon whether this profile is flat enough to be in dynamic equilibrium with the flashy urban runoff it is provided. Unfortunately, the likelihood is that it is not, and even more erosion will occur unless something is done to decrease the flashiness of the runoff.

3. Most of the bridges serve as grade control structures, and this can be seen by looking at the profile at these points. Bridges at Adobe, Capistrano, Linda Mar and Oddstad all force the creek through concrete box culverts, creating a limit to downward erosion at that point in the profile. This invariably creates a fish migration barrier as a steep step and deep pool develops downstream.

4. Below the North Fork confluence and extending downstream to the next grade control structure at Linda Mar Bridge, the gradient has similarly been flattened as a result of urban runoff, primarily from the North Fork watershed and delivered by its system of culverts draining Park Pacifica. While the upper terrace gradient is 1.85% in this reach, the water surface and bankfull gradients are 1.09% and 1.07% respectively.

5. For the same reason, the main-stem upstream of the North-Fork confluence has been *steepened* to a gradient of 1.8%. This is because the downcutting below the confluence creates a steeper gradient in the main channel draining into it. This steeper gradient will no doubt create a headcut, which will migrate upstream until it reaches the next grade control structure at Oddstad Bridge. This is where we should expect the next major barrier to fish migration, as a deep pool develops downstream of the concrete pad under the bridge.
