CHAPTER 4 – METHODS

Methods Specific to this Study

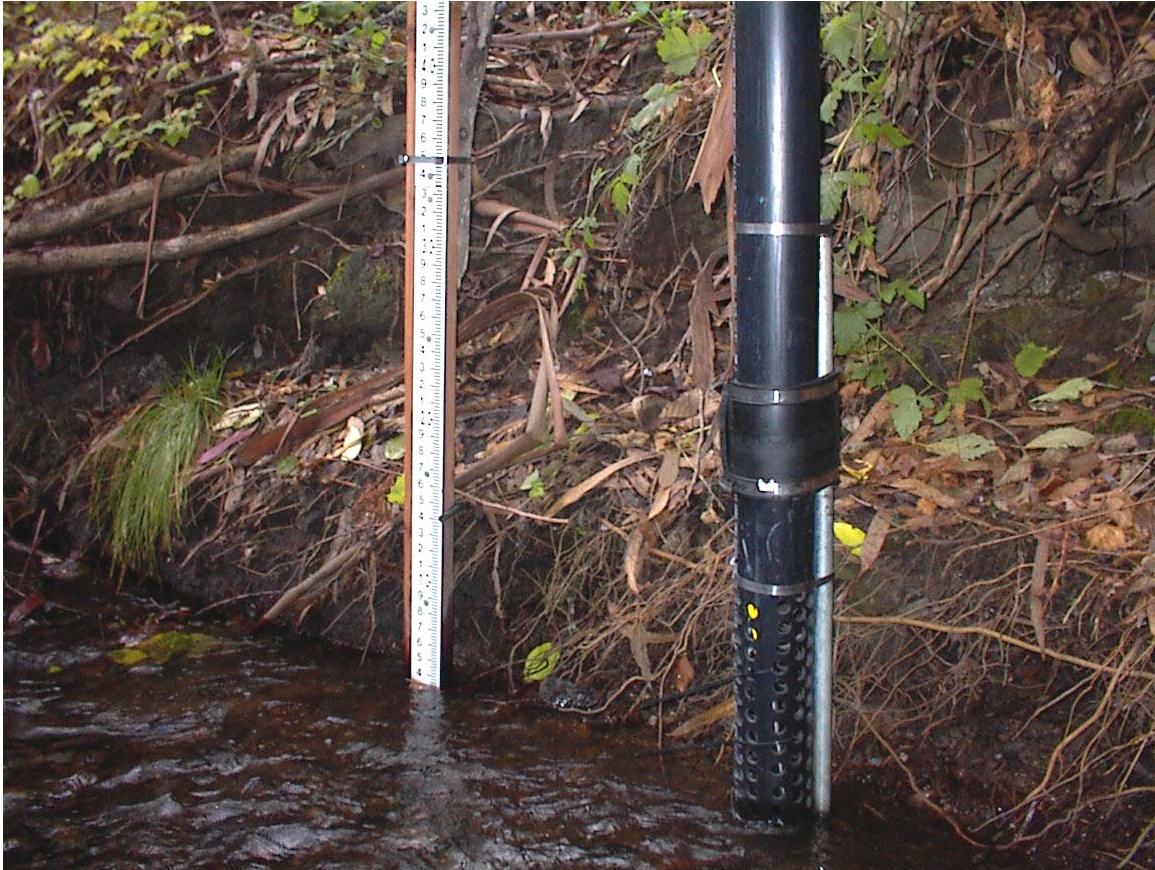
The gage station was located on the north bank at the end of a long riffle with earthen banks and gravel substrate. The bed and bank at the gage were relatively stable but did exhibit some signs of active erosion. As shown in Photo 4, sensors were housed in a black 5-inch (127 mm) diameter PVC pipe mounted perpendicular to the channel bed. Several holes were drilled into the bottom of the pipe to allow water-level equalization and through-flow while protecting the sensors from debris and sediment impact during storm flows. The sensors were connected to a data logger in a waterproof bucket hidden in a pit in the terrace above the channel, an accessible but secure location that allowed for regular data downloads and maintenance while protecting the equipment from tampering

or theft. A staff gage was placed next to the sensors for calibrating the water level data measured by the sensor with actual measured water level.

Photo 4. Middle Fork Gage Station

The Middle Fork gage station was located in San Pedro Valley County Park upstream from the urbanized portion of the watershed. The only man-made structures upstream of this station were a small maintenance yard and two small bridges located upstream of the gage. Residential and commercial facilities in the lower 1,300 feet (396.2 m) of stream contribute urban stormwater runoff to the Middle Fork and were thus excluded from the study area so that data collected at the gage would more accurately represent the undeveloped open space that dominates the Middle Fork watershed. The maintenance yard and pedestrian bridges were expected to have negligible influence on the stormwater runoff response and turbidity levels in the Middle Fork. The effects of trails on runoff and turbidity rates were considered beyond the scope of this study.

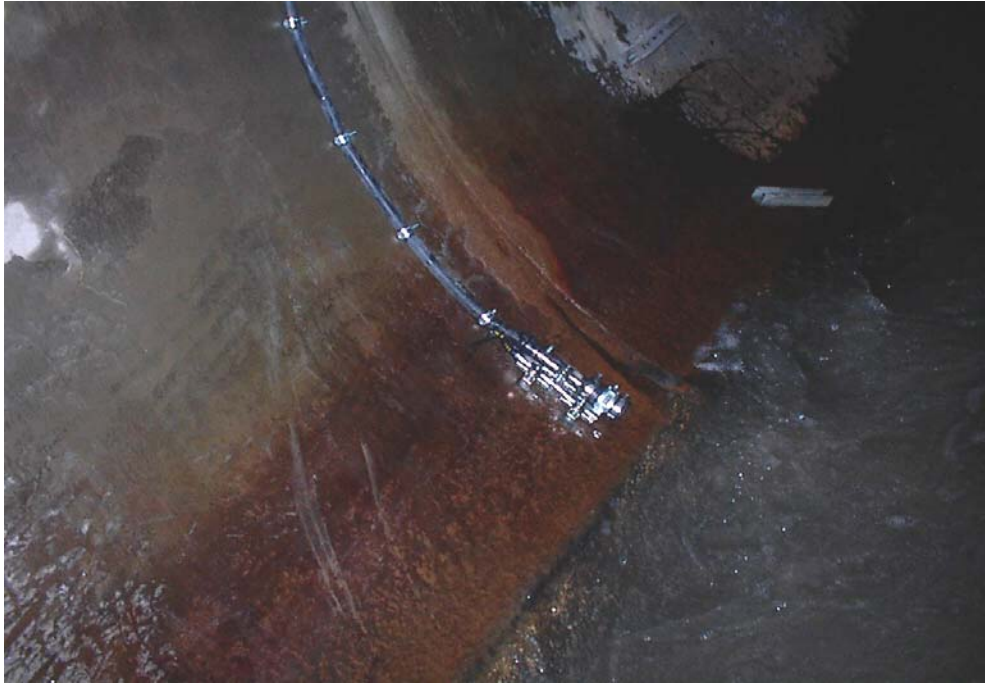
The North Fork gage station was located inside the 8-foot (2.4 m) diameter concrete pipe that forms the lower reach of the tributary, approximately 350 feet (106.7 m) upstream of its confluence with the Middle Fork. As shown in Photo 5 and 6, sensors were installed inside the pipe, 50 feet (15.2 m) from the end so they would be out of sight and safe from potential vandalism by juveniles

and transients known to frequent the area. The need for this precaution was reinforced by personal encounters and observations of conditions at the site. The sensors and data cables were bolted to the concrete pipe and routed to a waterproof bucket containing the data logger. A PVC sensor well was originally installed but was washed out by minor storm flows prior to installation of the sensors, providing a timely indication of the velocities at which the culvert conveys flow. The sensors were re-mounted near the bottom of the concrete pipe without any housing.

Photo 5. North Fork Gage Station Inside Culvert

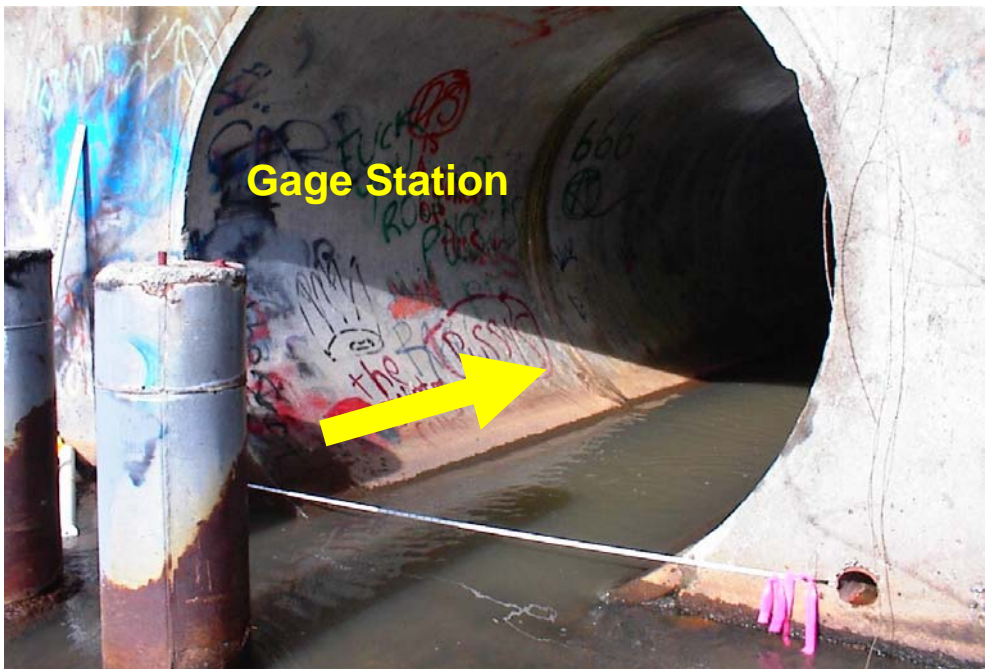
Photo 6. North Fork Culvert
