6. Conclusions

6.2 Proposed recommendations for sediment mitigation

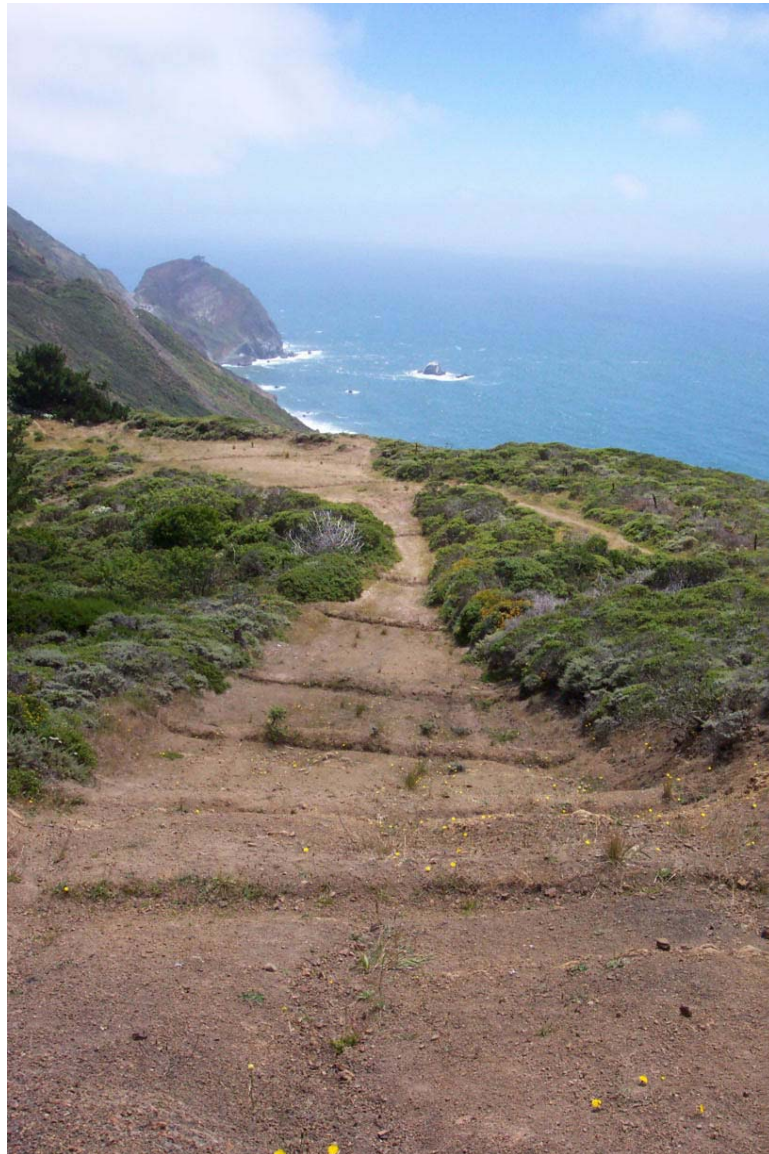
Figure 101: Existing and apparently effective sediment control measures implemented in Pedro Point II subwatershed.

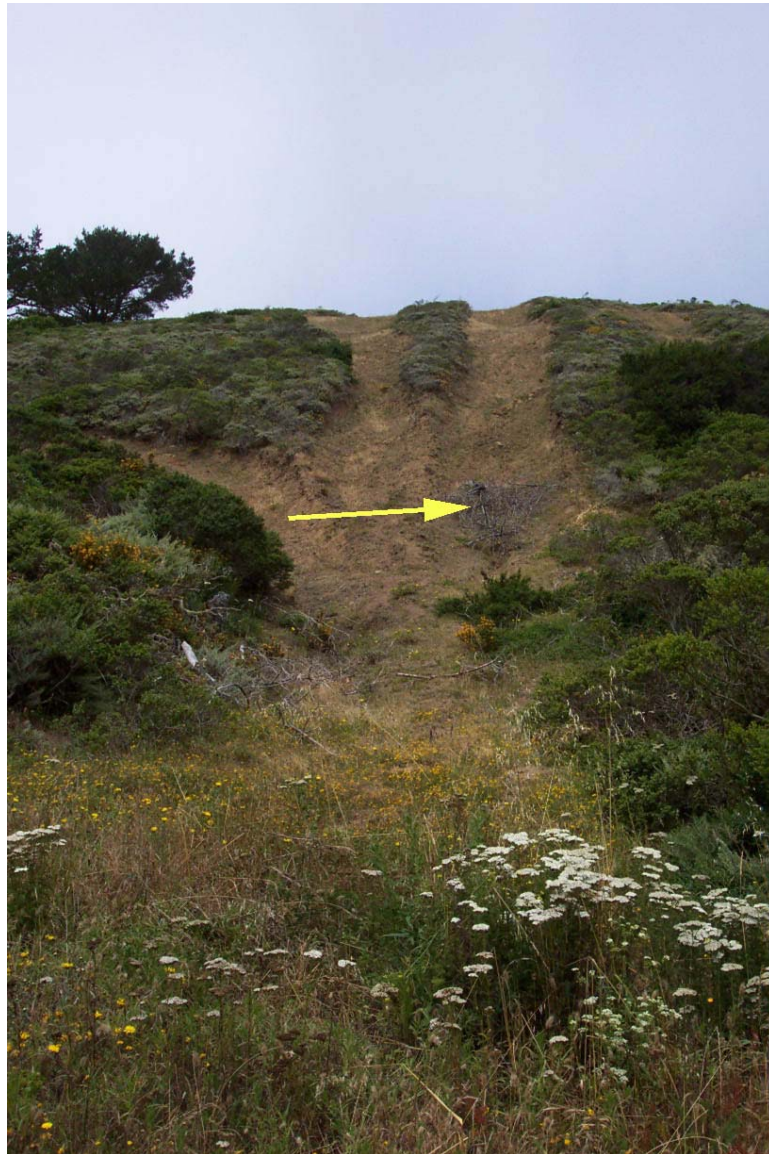
Figure 102: Tree and shrub cuttings (at arrow) placed along trail in an area with deep incision to reduce erosion and promote vegetation growth.

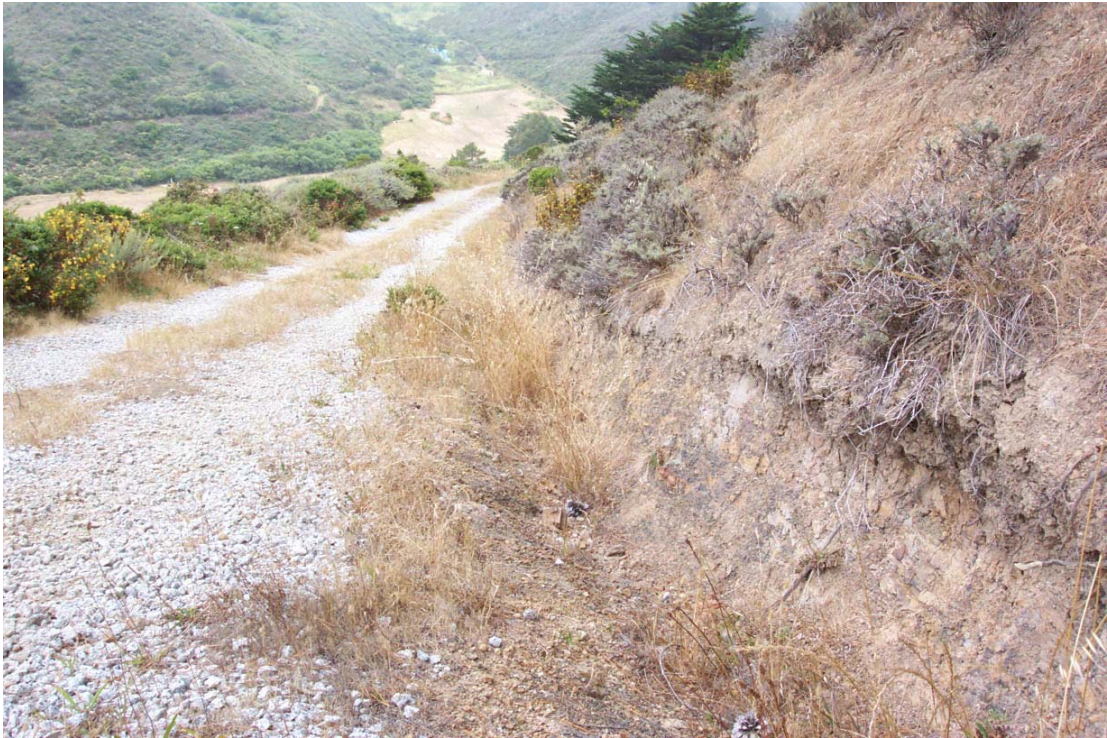
Figure 103: Large gravels spread onto the nearly impervious surface of the road. Over time the gravels will aerate the soils making the road more permeable to moisture.

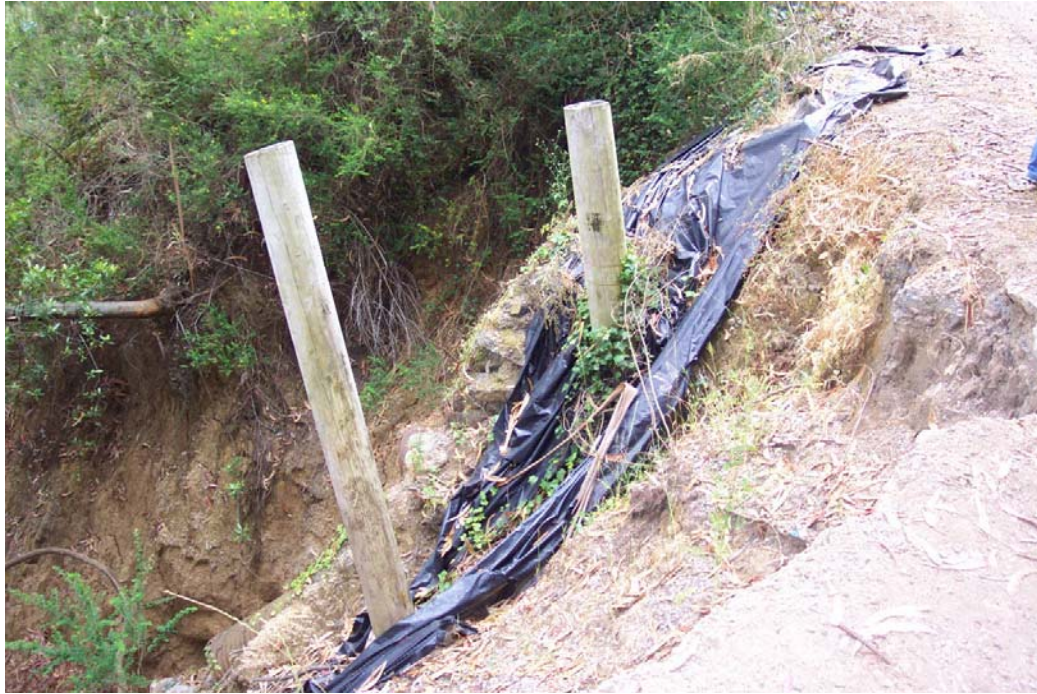
Figure 104: Ineffective erosion control structures. Tarps have washed downslope over the sandbags supporting the trail in just one rainy season.

Some of the simpler engineering structures already in place that have proven to be ineffective could be modified or removed. Tarps draped across problem areas to abate surface erosion prevent both evaporation of saturated soils and establishment of vegetation. In a few areas, these tarps have washed downslope and are now preventing new vegetation from growing where they have been displaced (Figures 104 & 105). The partially paved Coastside Boulevard (Figure 106) that was built in 1915 (VanderWerf 1994) concentrates runoff to a few sites on the lower slopes creating gullies. Erosion in one gully is so severe that sandbags, tarps, retention poles, and a failing culvert have been

installed to stabilize the trail and try to reduce further erosion (Figure 104). While delaying erosion, these props are proving to be ineffective in impeding long-term erosion. Removal of the pavement along the trail, aeration of the underlying soils, and installation of many more water bars would effectively diffuse runoff and reduce the erosion at this concentrated site. To effectively mitigate sediment generated from this gully and prevent further incision, large-scale modifications would likely need to be made to the gully due to the already extensive depth. General incision along many of the trails throughout the subwatershed is severe enough in places that grading followed by the installation of new water bars may be necessary.

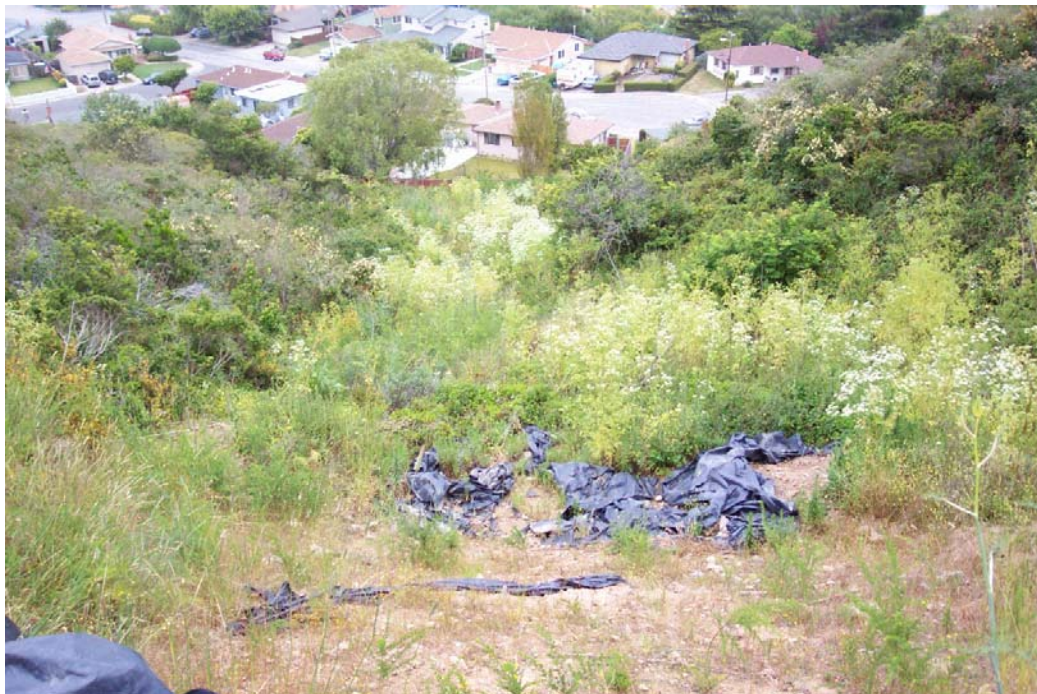
Figure 105: Tarps proving to be ineffective control measures have washed downslope of an area of an eroding area along the Coastside Boulevard.

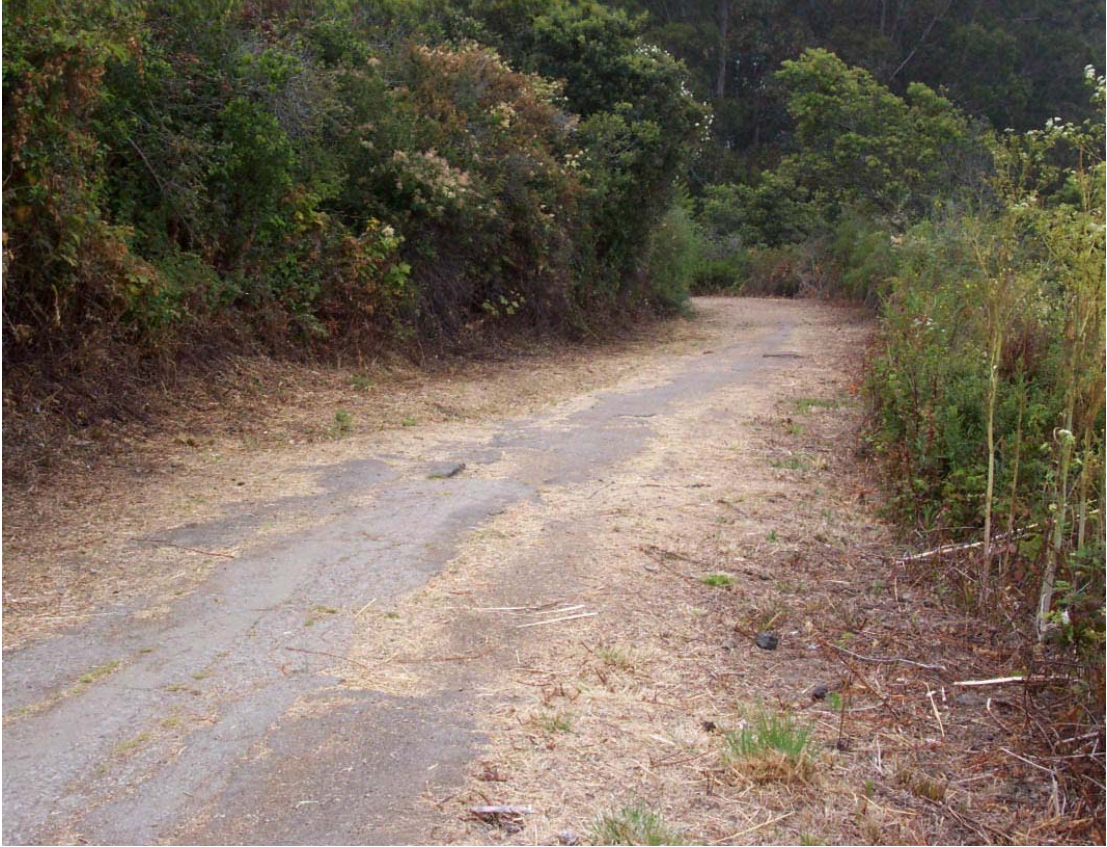
Figure 106: The partially paved surface of the Coastside Boulevard.

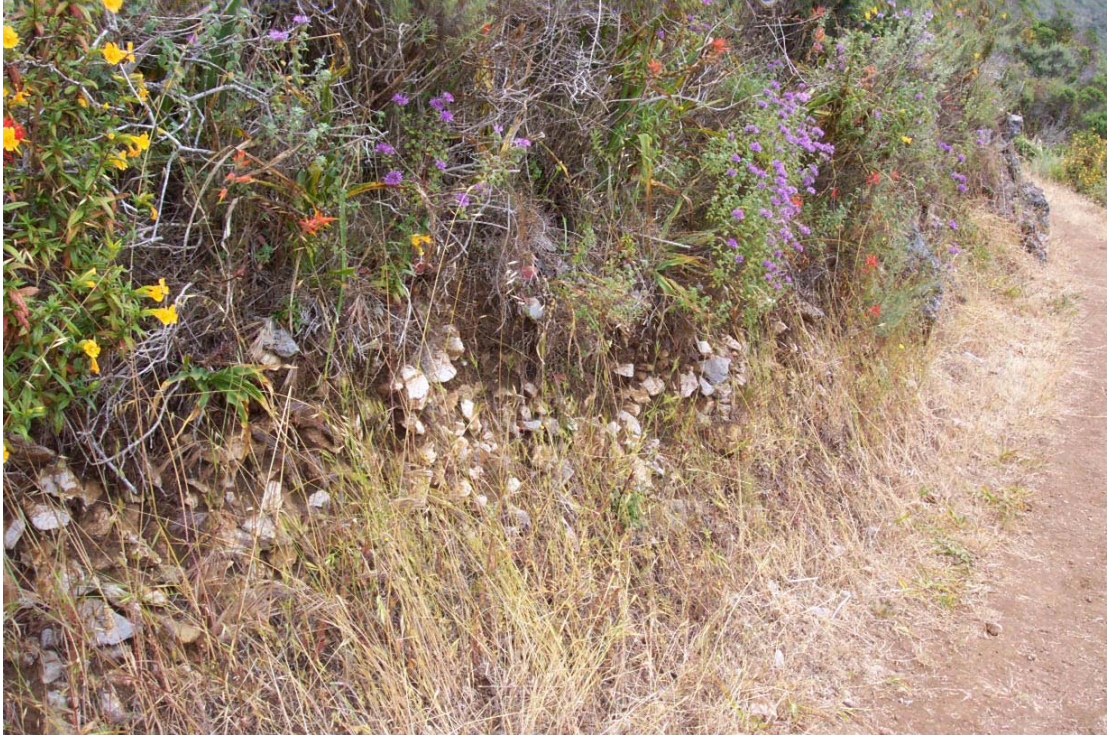
Figure 107: Unconsolidated landslide material along the upper hillslope of the Valley View Trail in the Middle subwatershed. Landslides were not observed on aerial photographs but evidence of occurrence was found in the field.

- Smaller landslides may not have been observed when occurring between years of aerial photographs. Colluvium was discovered along upper trail cuts in several locations where no evidence of upslope landslides was found on the aerial photographs (Figure 107).
